MOONEY SPECIAL LETTER 15-17
Date: 9-21-2015

SUBJECT: To ADVISE MOONEY OWNERS/OPERATORS of the **LYCOMING Service Bulletin No. 621A (Supersedes Service Bulletins No. SB-621) Issued September 2, 2015 - Diaphragm-Type Fuel Pump Replacement (see attached).**

DATE: September 2, 2015 Service Bulletin No. 621A
(Supersedes all versions of Service Bulletin No. 621)
Engineering Aspects are
FAA Approved

SUBJECT: Diaphragm-Type Fuel Pump Replacement

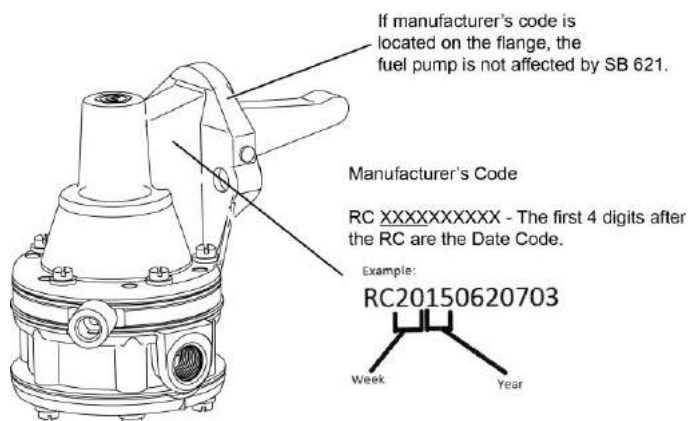
NOTICE: Each fuel pump has a 13-digit alphanumeric manufacturer’s code, which begins with two letters as shown in the example in Figure 1. The alphanumeric characters in the manufacturer’s code and its location on the fuel pump will help identify the fuel pumps affected by this Service Bulletin. The first two characters in the example manufacturer’s code RC20150620703 in Figure 1 are **RC**. The next two numbers **20** identify the manufacturing week of the year as **20** and **15** is the year. The manufacturer’s code is on the fuel pump flange or on the web as shown in Figure 1. If the manufacturer’s code is on the flange as in the example in Figure 2, the fuel pump is not affected by this Service Bulletin.

Figure 1
Manufacturer's Code Location on
Fuel Pump P/Ns 62B26931 and LW-16335

1. If the fuel pump is Lycoming part number 62B26931 or LW-16335.
2. If the manufacturer's code is not on the flange but is on the web or other parts of the fuel pump.
3. If the fuel pump has **RC** (Figure 1) as the first two letters of the manufacturer's code.
4. If the manufacturer's code identifies the fuel pump as manufactured before, up to, and including the 25th week of 2015.

If any fuel pump meets **all** the criteria above, remove the fuel pump from the engine or from the spares inventory and:

- A. Review your records to identify shipping dates of the serial numbers of any of the affected fuel pumps.
- B. Return all affected fuel pumps to Lycoming Engines with a copy of this Service Bulletin and file a warranty claim per the warranty procedure herein.
- C. Record removal of the fuel pump installed on the engine in the engine logbook.

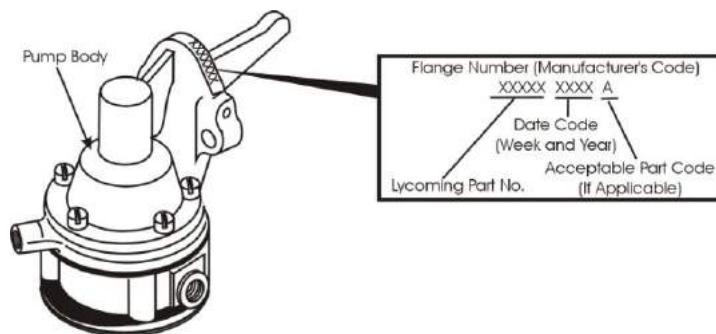
Figure 2
Manufacturer's Code on the Flange
(Fuel Pump Is NOT affected by SB-621)
