MOONEY INTERNATIONAL CORPORATION SPECIAL LETTER

SPECIAL LETTER 18-18
Date: 12-18-2018

SUBJECT: To ADVISE MOONEY OWNERS/OPERATORS of the **Continental Motors Aircraft Engine SERVICE BULLETIN SB18-07, Dated: 11/19/2018 - Subject: Crankshaft Dowel (P/N 536563) Inspection and Replacement Instructions at Maintenance and Overhaul**

SERVICE BULLETIN**SB18-07**

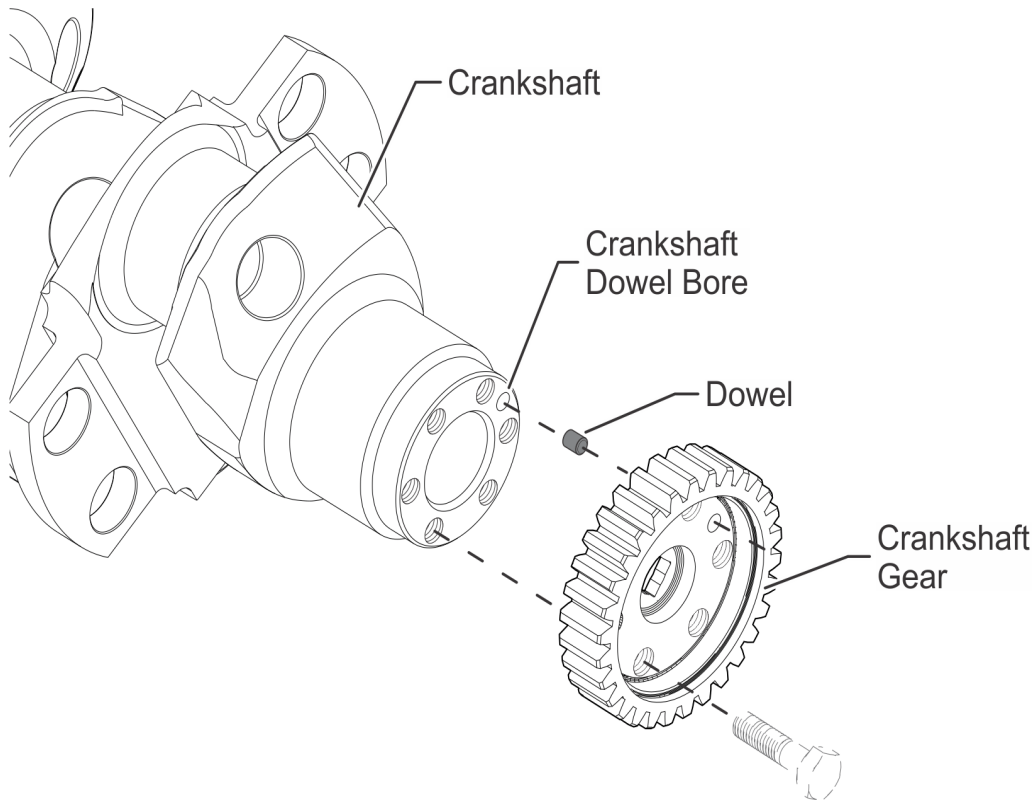
Figure 1. Crankshaft Dowel Bore and Dowel Locations, typical

The crankshaft dowel is installed with an interference fit. The dowel is used to positively orient the crankshaft gear to the crankshaft. At the next maintenance event requiring complete disassembly of the engine or at overhaul:

1. Remove the existing crankshaft dowel with a slide hammer fitted with an adjustable chuck.
2. Inspect the crankshaft dowel bore for cracks; replace the crankshaft if cracks emanate from the dowel bore.
3. Inspect crankshaft dowel bore and ensure dowel bore meets specifications defined in Table 2.
4. Dry fit the new crankshaft dowel for a minimum 0.0002" interference fit (reference Table 2).

6. After crankshaft dowel replacement, inspect the:
 - a. dowel with a tool maker's square for proper alignment and seating height extending from the crankshaft flange (reference applicable ICA).
 - b. crankshaft and dowel bore area for cracks. Replace the crankshaft if cracks emanate from the dowel bore.
