MOONEY INTERNATIONAL CORPORATION SPECIAL LETTER

SPECIAL LETTER 18-19

- SUBJECT:** To ADVISE MOONEY OWNERS/OPERATORS of the **Continental Motors Aircraft Engine SERVICE BULLETIN SB18-08, Dated: 12/10/2018 - Subject: Inspection and Maintenance Modifications of Cylinder Assemblies.**

SERVICE BULLETIN

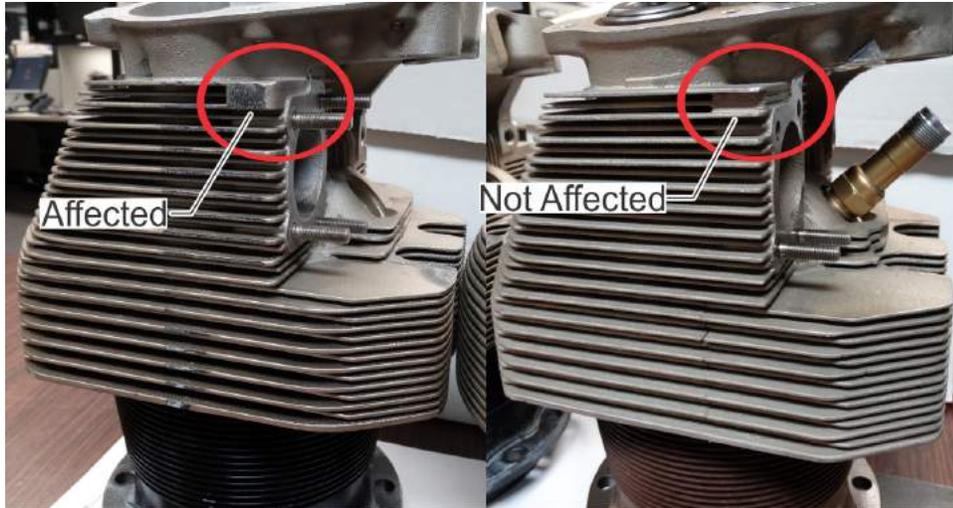
Figure 1. Affected Cross Flow Cylinders, Top Fin Flange typical

Several field reports indicate the potential for fracture initiation on engines (exceeding 500 hours of operation) at the radius edge of identified cylinder heads produced on or after 01 NOV 2014 (see Figure 2). The affected cylinder casting can be identified by the “filled” top fin flange area above the exhaust port as shown in Figure 1.

Identified Cylinder Assemblies, Replaced After 01 Nov 2014

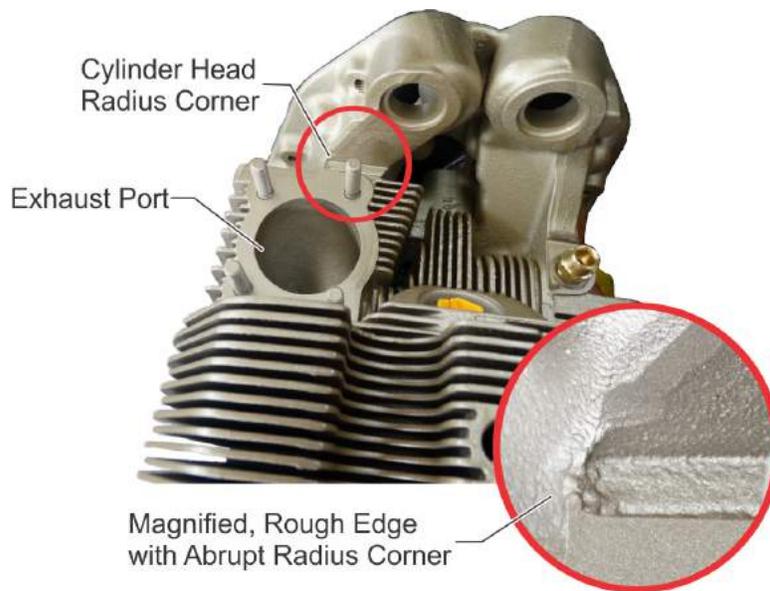
Figure 2. Abrupt Radius Edge with Flash Material Build-up, typical

4. Begin removing built-up flash material using a pencil grinder or 1/4” round metal file held approximately at a 30 degree angle (i.e. Nickolson Bastard Cut file, see Figure 7).

Carefully, vary your filing motion until a smooth, blended “tapered” radius edge is achieved at the radius corner. Remove ONLY enough material from the cylinder head to achieve dimensional specification, see Figure 4. The finished radius blend should not exceed 0.20” depth of the material removed.

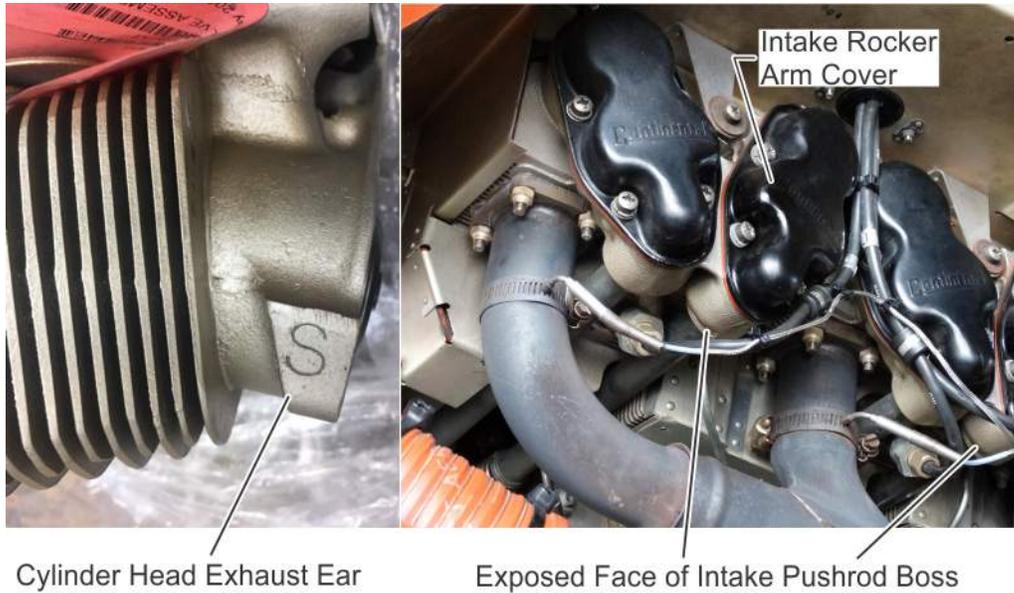
Figure 3. Cylinder Head Indicates Prior Compliance, Stamped with Letter “S”

6. Metal stamp the letter “S” (1/4” stamp) on the face of the intake pushrod boss (reference Figure 3) to indicate part compliance.
7. Use compressed air and a clean dry rag to remove residual material.

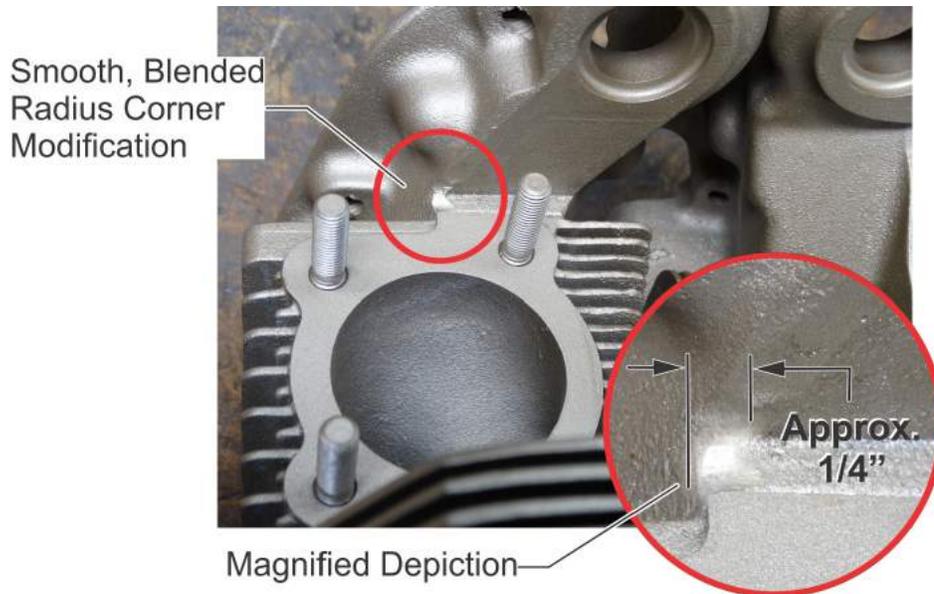
Figure 4. Smooth Radius Corner after Radius Blend Modification

5. Inspect the cylinder head surface and remove all nicks, burrs, sharp angles or edges using a de-burring tool and Scotch-Brite© (ultra fine or equivalent). Evenly shape, taper, and smooth all interfering surfaces where material was removed (see Figure 4).

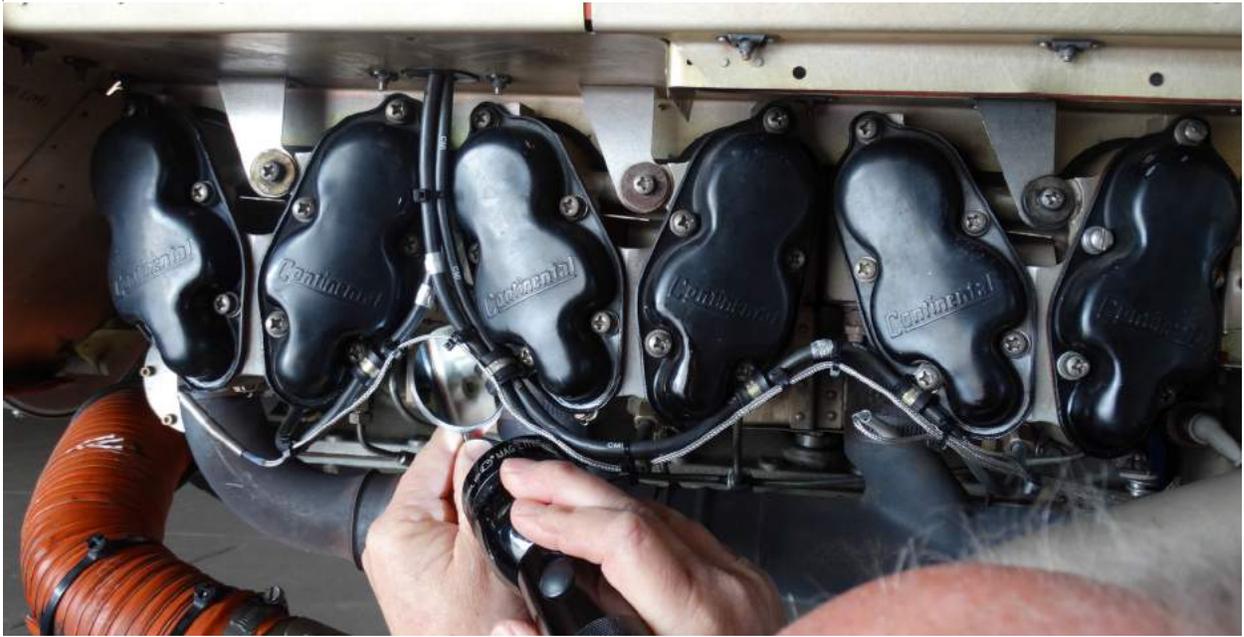
2. If the cylinder head exhaust ear is not stamped with the letter “S” or is obscured by baffling, inspect the radius corner angle below the exhaust port (see Figure 5) for any casting flash build-up or sharp radius edges. The radius corner should be tapered and blended smooth (reference Figure 4).

Figure 5. Cylinder Head Inspection Area, typical aircraft installation

3. Perform a “Non-Destructive Visual Inspection” according to the latest instructions in M-0, Standard Practice Maintenance Manual, Chapter 11, on the cylinder head radius corner (all possible angles). All cracks require attention, regardless of size or location. If a fissure, crack or physical damage is identified, replace the cylinder. Contact CMI Customer Service (Section V on page 6) to order replacement parts.

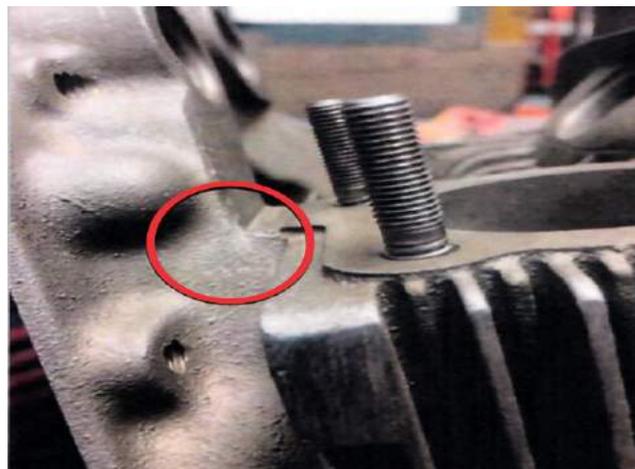
Figure 6. Cylinder Head Radius Corner, side view

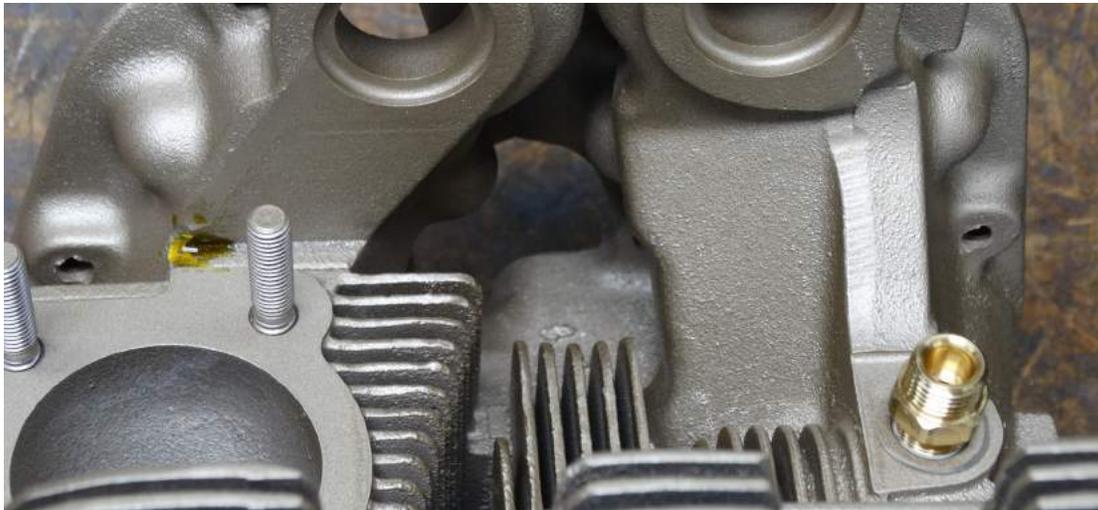
Figure 8. Cylinder Head, Alodine Application

8. Use an alodine touch up pen (Alodine® 1132™ Touch-N-Prep® Coating, Henkel Corporation) or equivalent (as specified by MIL-DTL-81706B, (PIN M817061A6D)) to apply alodine to machined areas or any other areas of exposed metal, as instructed by the engine’s primary Instructions for Continued Airworthiness (ICA).
9. Create a logbook entry detailing the compliance action taken in accordance with this Service Document (SB18-08). The logbook entry must record all cylinder head serial numbers and include a complete listing of parts used in this installation.
10. If any equipment was removed to gain access, continue with engine assembly according to the primary Instructions for Continued Airworthiness (ICA).
