# MOONEY INTERNATIONAL CORPORATION SPECIAL LETTER

SPECIAL LETTER 18-20

- SUBJECT:** To ADVISE MOONEY OWNERS/OPERATORS of the **Continental Motors Aircraft Engine SERVICE BULLETIN SB18-04A, Revised Date: 12/18/2018 - Subject: Replacement of Flanged Nut (P/N 652541) Identified with Manufacturer's Stamp "ZB"**.

**SUBJECT:** Replacement of Flanged Nut (P/N 652541)  
 Identified with Manufacturer’s Stamp “ZB”

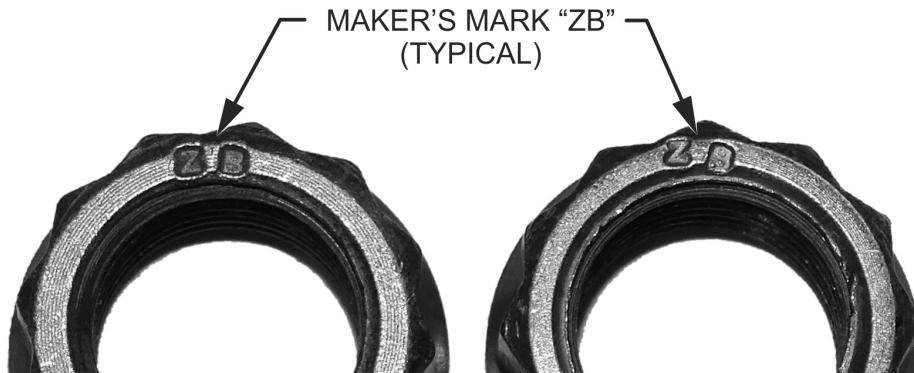
Continental Motors, Inc. (CMI) has seen evidence of dimensional non-conforming conditions for a limited production of flanged nuts (P/N 652541).

The manufacturer’s stamp is used to identify those flanged nuts which require replacement (maker’s mark, “ZB” on the outer-edge of the nut head, see Figure 1).

Figure 1. Flanged Nut, Manufacturer’s Stamp, (maker’s mark, affected)

1. Identify the affected flanged nut by the manufacturer’s stamp (maker’s mark) as “ZB” on the outer-head edge (see Figure 1).

1. This Service Document creates a required replacement procedure for the through-bolt, flanged nut (P/N 652541) identified with manufacturer’s stamp “ZB” at the next 100-hour “Engine Inspection” (see Section COMPLIANCE, above).
2. Replace all flanged nuts (P/N 652541, as shown in Figure 1) in accordance with the procedures in Section III, “ACTION REQUIRED”.

2. All identified flanged nuts installed must be removed and replaced according to the applicable Maintenance and Overhaul Manual crankcase hardware instructions (one through-bolt at a time).
3. All identified flange nuts (removed or spares) must be returned to Continental Motors according to the instructions in Section IV on page 3.
4. As each nut is removed, visually inspect the through-bolt and crankcase hardware for thread damage:
  - a. If the crankcase hardware is not damaged (through-bolt threads, etc.), continue to Step 5.

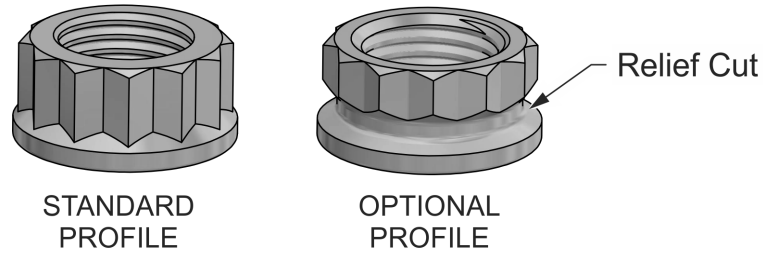
NOTE: Flanged nuts **purchased prior to 1 OCT 2017** or identified with the “OPTIONAL” profile (relief cut, as shown in Figure 2) **do not** require replacement.

Figure 2. Flanged Nut, Profiles
