SUBJECT: M20V ALTERNATOR WIRING, MOUNTING AND SECURITY
[Chapter 24 - ELECTRICAL POWER]

MODELS/ SN Mooney M20V - 33-0001 THRU 33-0018
AFFECTED:

SBM20- 340A Page 1 of 5

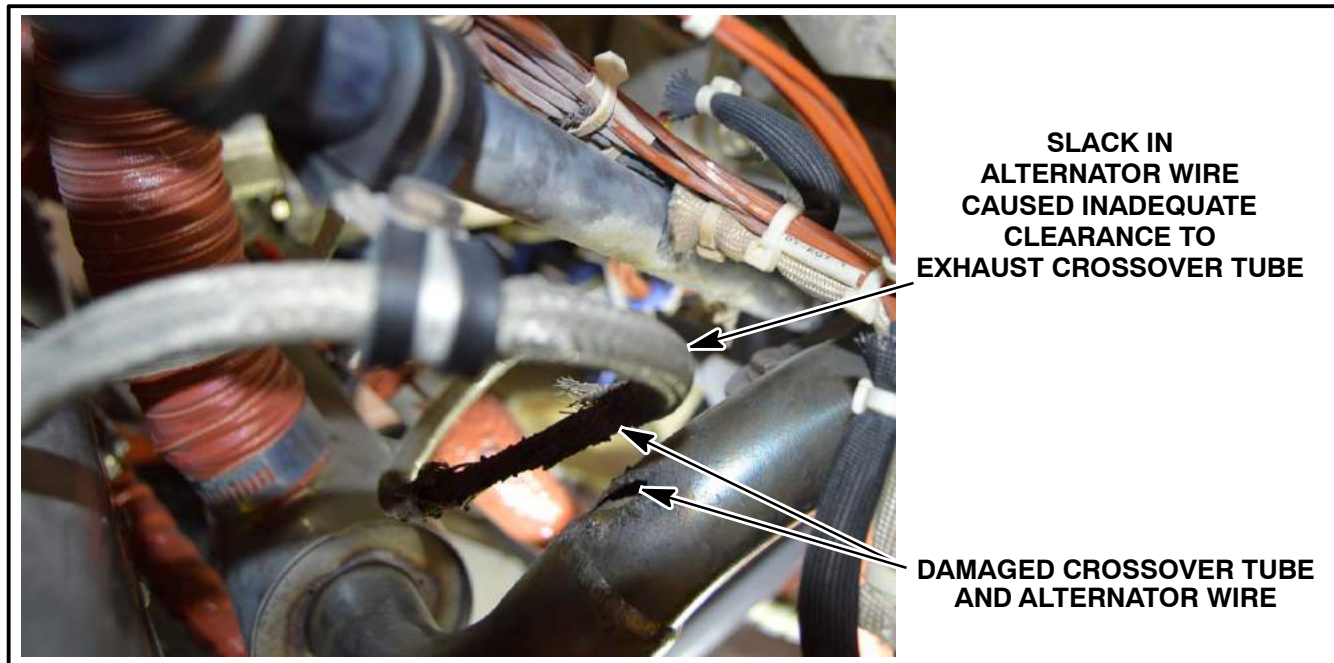
Figure SB M20-340-1 - EXISTING ALTERNATOR WIRE ROUTING

INTRODUCTION: There was a report in the field, of an M20V Acclaim Ultra with an alternator wire damaged on the RH exhaust crossover tube. Mooney Engineering has determined the wire was incorrectly positioned. This allowed the wire to contact the RH exhaust crossover tube causing a short circuit to the alternator. This resulted in damage to the wire and crossover tube. This requires mandatory compliance by owners. **The attached compliance card needs to be filled out and returned to Mooney International Corporation upon completion of this Service Bulletin M20- 340A.**

- 1.1. Turn master switch - OFF.
- 1.2. Remove top and bottom cowling, refer to Mooney Service and Maintenance Manual.
- 1.3. Locate upper alternator wire (refer to Figure SBM20-340-1). Inspect wire for any signs of damage; chafing, cracks in shielding, burnt spots, etc., if wire is damaged, contact MOONEY TECHNICAL SUPPORT support@mooney.com for a replacement wire.

- 1.4. Locate RH exhaust crossover tube. Inspect for damage; holes, cracks, etc., if damaged contact MOONEY TECHNICAL SUPPORT support@mooney.com for a replacement crossover tube, refer to Figure SBM20-340-1.
