# MOONEY INTERNATIONAL CORPORATION SPECIAL LETTER

SPECIAL LETTER 19-14  
Date: 12-18-2019

**SB19-09**TECHNICAL PORTIONS  
FAA APPROVED

**SUBJECT:** Champion Aerospace Slick Service Bulletin SB2-19

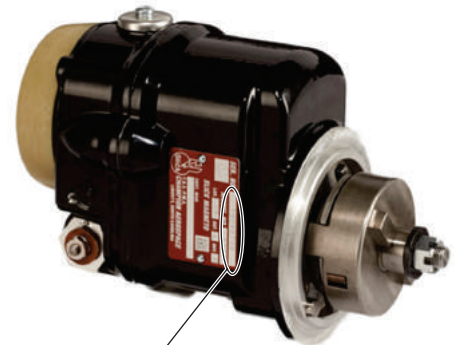
LETTER "B" INDICATES REPAIRED MAGNETO

SERIAL NUMBER LOCATED ON MAGNETO DATAPLATE

MANUFACTURED DATE LOCATED ON IMPULSE COUPLING REPLACEMENT KIT

1. Locate magneto serial number on magneto dataplate or purchase date of replacement impulse coupling kits. If the magneto serial number or impulse coupling purchase date is determined to be within the range specified in this bulletin and the dataplate is not stamped with the letter "B" per the WARRANTY description above, remove the magneto from engine in accordance with the latest revision of the engine manufacturer's manual(s).

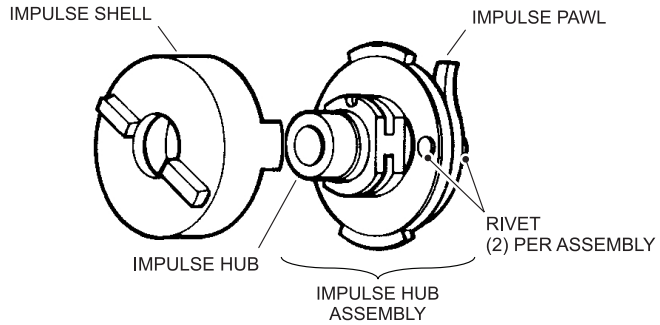
- Remove, disassemble, and clean the impulse coupling per current revision of applicable magneto manual and per current revision of F-1100 Master Service Manual or L-1500 LASAR Master Service Manual.
- Inspect the impulse coupling per the maintenance manual. If any movement is found in the rivets, the impulse coupling must be rejected. Reference WARRANTY INFORMATION for resolution options.

- Repeat this recurring inspection per the requirements listed in the COMPLIANCE section.
- In no instance shall a repair of the impulse coupling be attempted for loose rivets.
- Liberalily oil ALL new or removed impulse couplings with clean engine oil prior to installation. Make sure all castellated drive nuts are torqued to 120-320 in-lbs. Reference Champion Service Letter SL1-17 for additional information.
